HEAVY WEATHER

Weather occurrences are not “just the cost of doing business” – their risks can be managed, says John Dutcher.

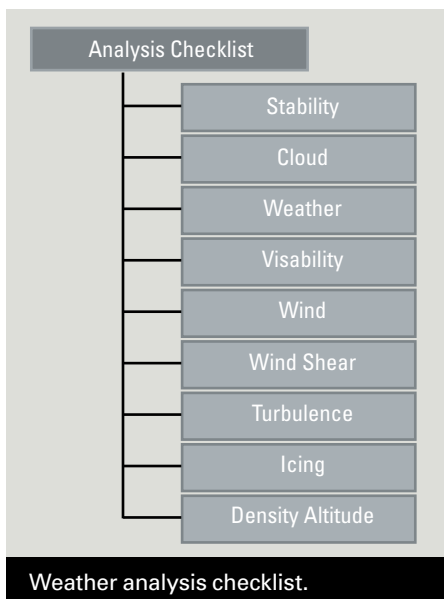
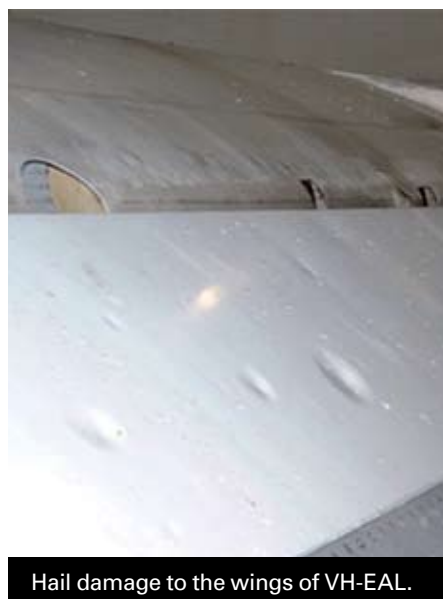
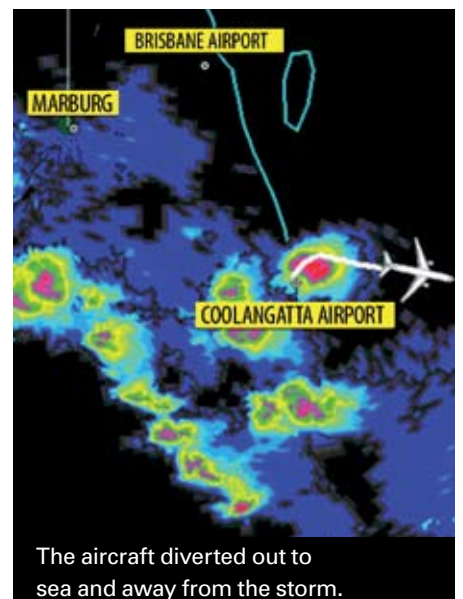
A sound framework for analysing weather related hazards and incidents is critical. You need to look at a range of contributing factors, and this can be done using a "weather analysis checklist" (see diagram).
